POND MANAGEMENT STRATEGIES

Seniors Resource and Recreation Centre
Brydon Lagoon
Sendall Gardens

CITY OF
LANGLEY

Submitted by:
Dillon Consulting Limited
3820 Cessna Drive, Suite 510
Richmond BC
V7B 0A2

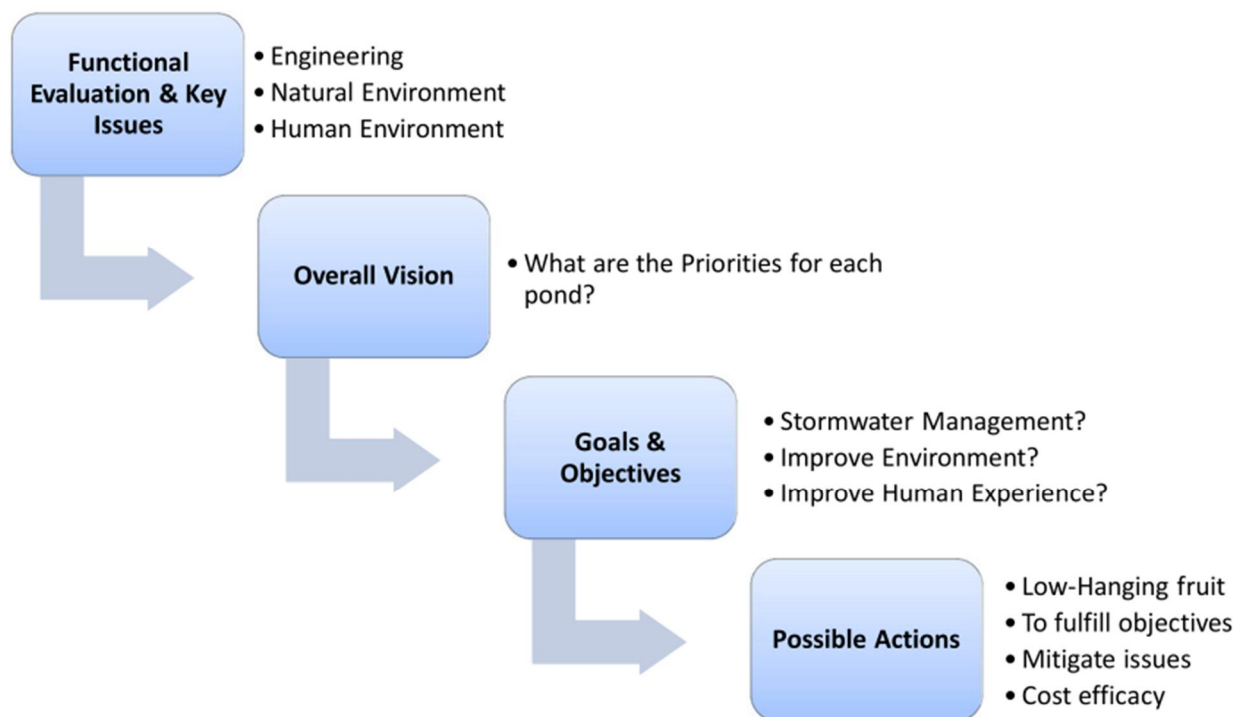
Figure 2: The Visioning Framework

For this project, a visioning framework was applied to form and evaluate the many components of the strategy, as shown in Figure 2 below.

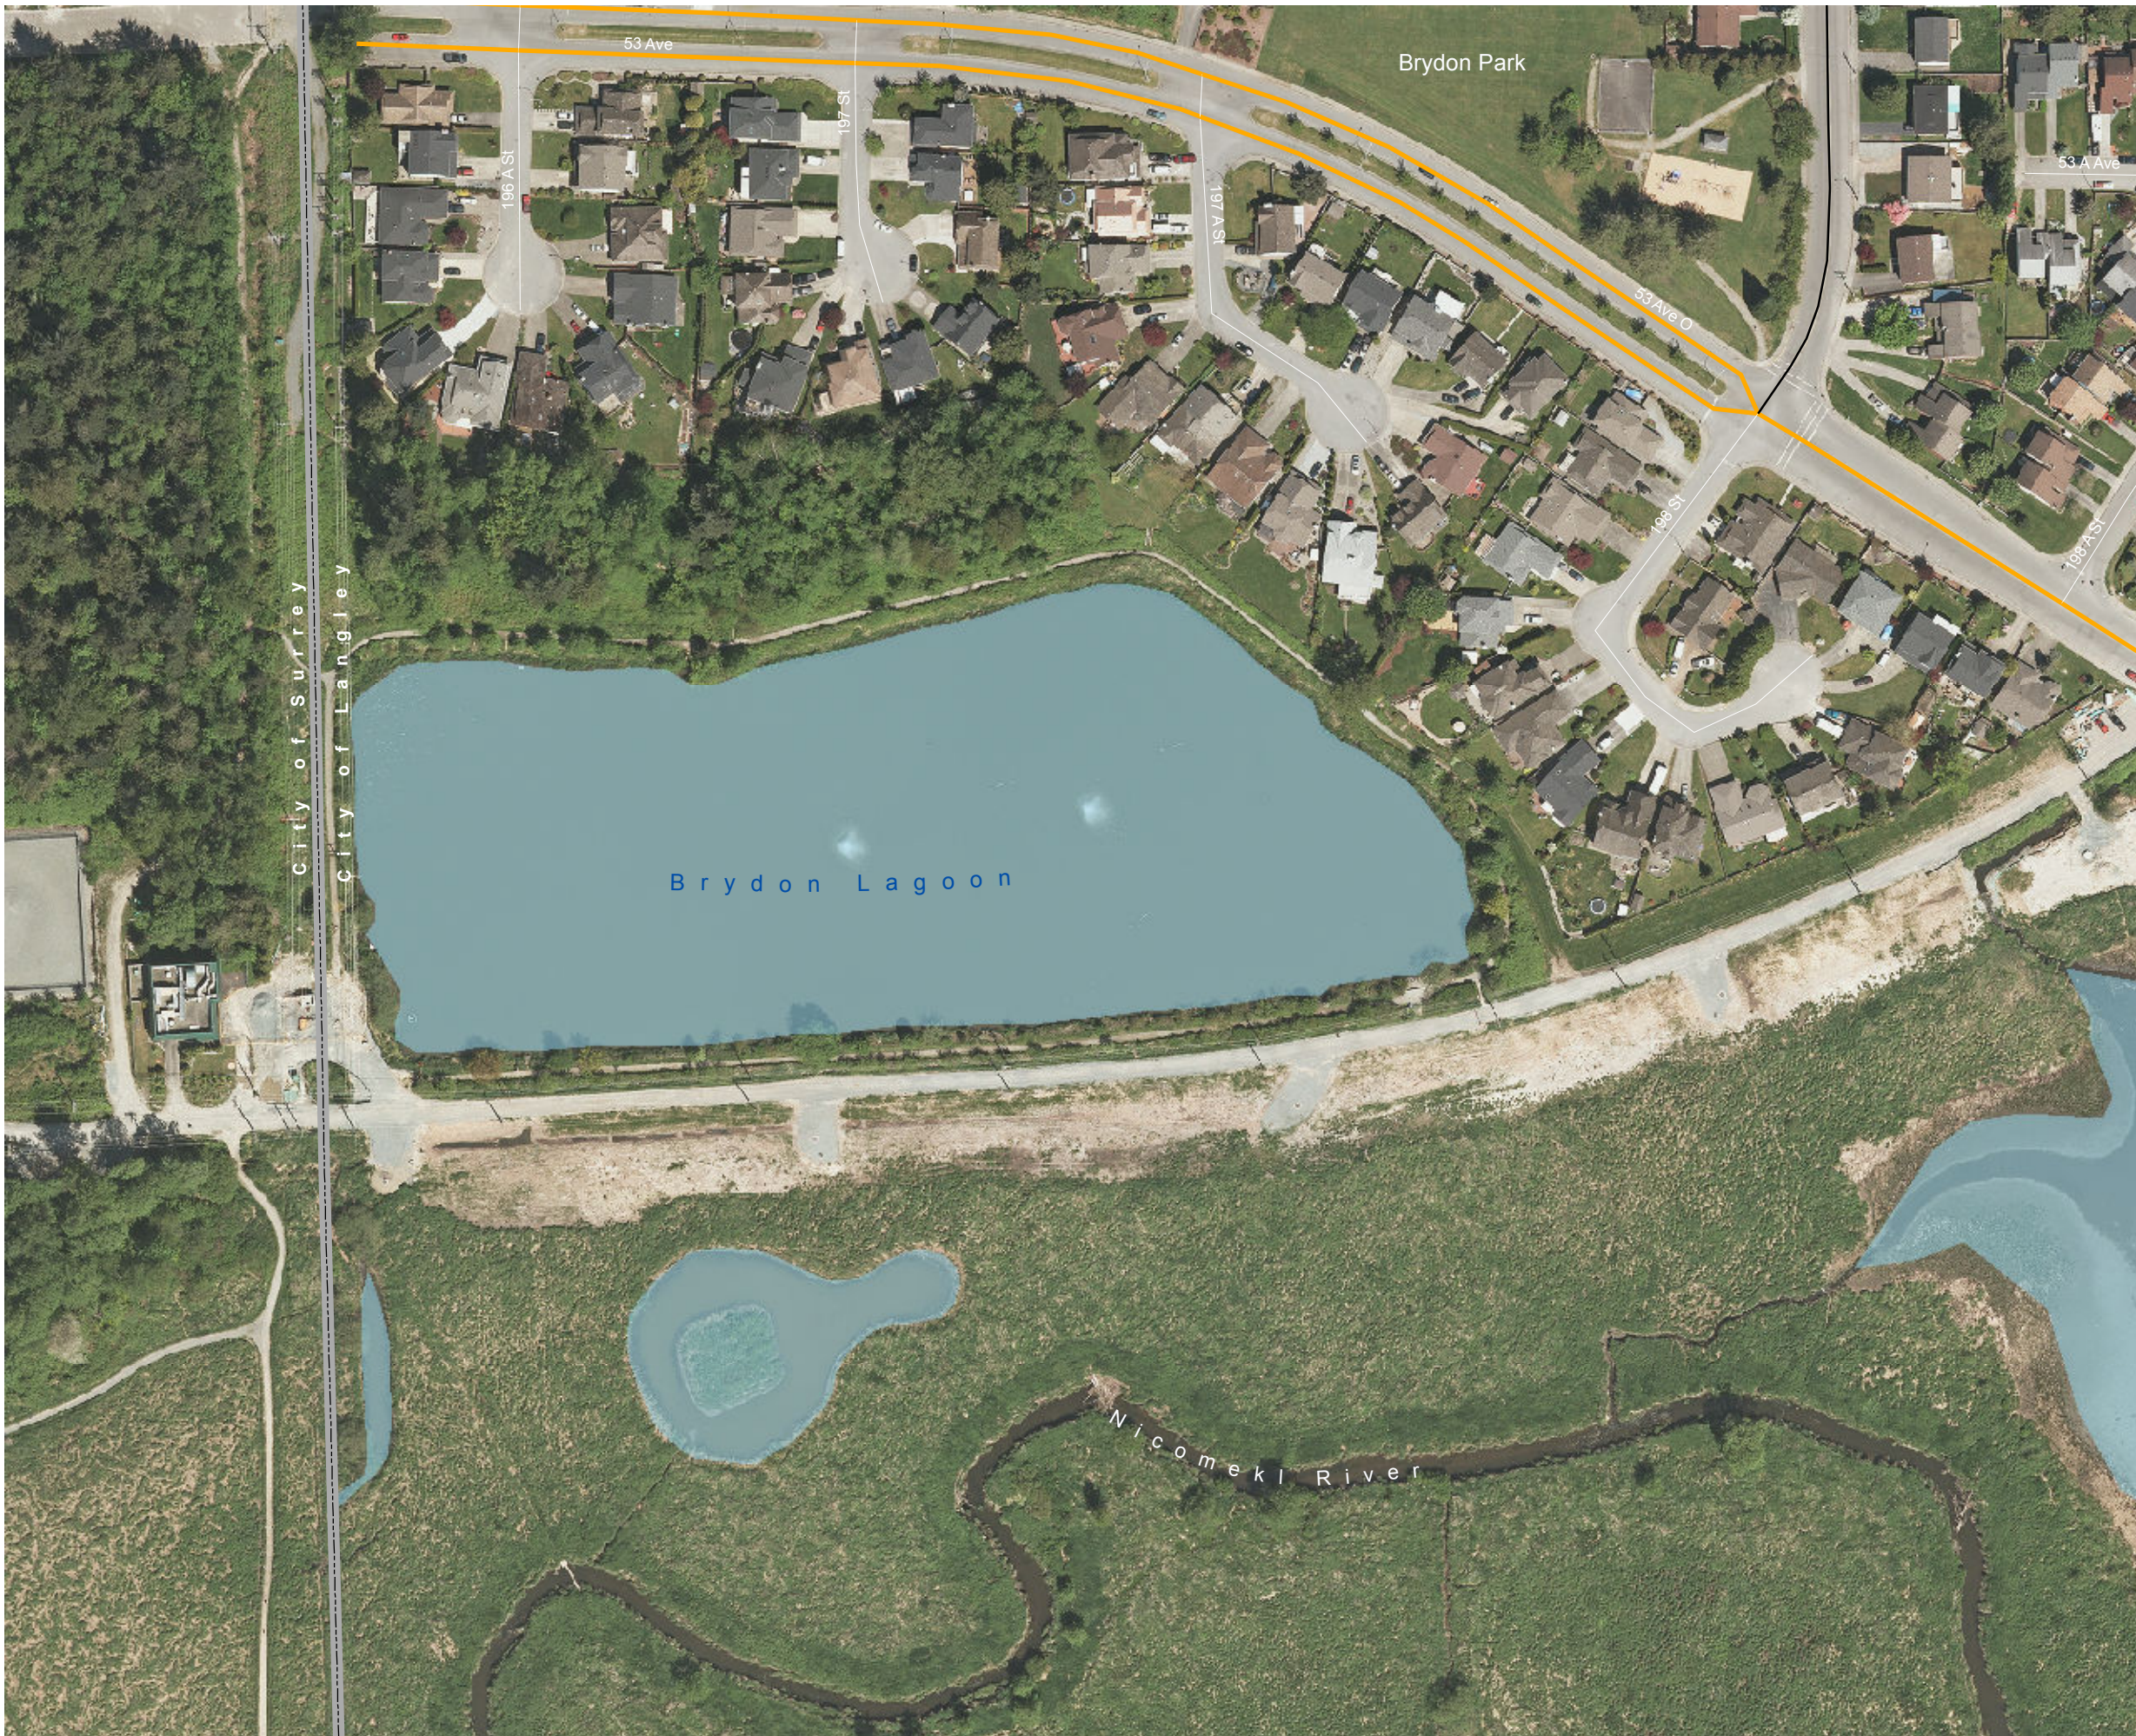
Brydon Lagoon
Location Plan

The local context of Brydon Lagoon is shown on Figure 3 on the following page.

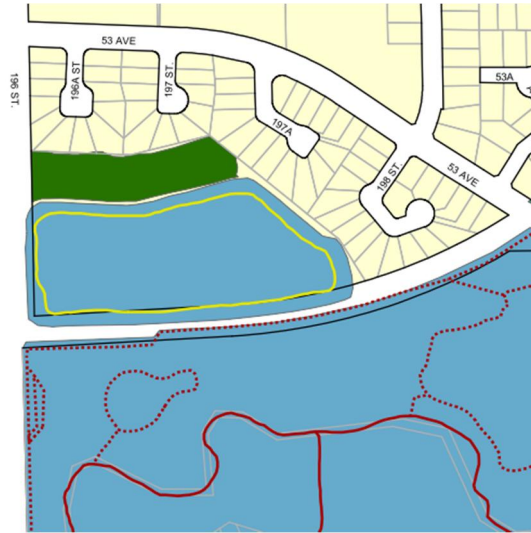
Figure 6: Brydon Lagoon – Environmentally Sensitive Areas Context

Environmentally Sensitive Areas

- Ravine & Watercourse
- Forested Areas/Trees/Snags
- BC Hydro ROW
- Floodplain & Wetland

Brydon Lagoon is located in the floodplain and wetland component of the City's Environmentally Sensitive Areas (See Figure 6 on following page), and the forest to the north of the lagoon is also identified as an Environmentally Sensitive Area.

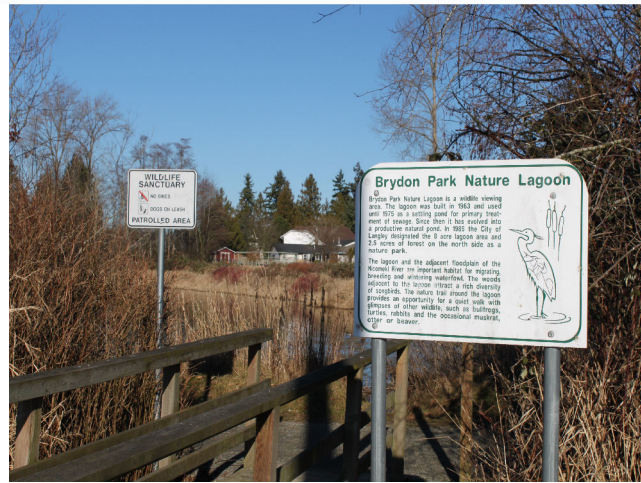
6 ↗ Site Entrance

Brydon Lagoon
Key Issues
Figure 8

During the Functional Evaluation a number of key issues were identified, which are summarized in this section. Issues that can be represented spatially are shown on Figure 8 on the following page, with corresponding photographs.
